HRT HOME SOLUTIONS LLC

## RESIDENTIAL REPORT

1234 Main St. CAMERON North Carolina 28326

01/20/2021 9:00AM

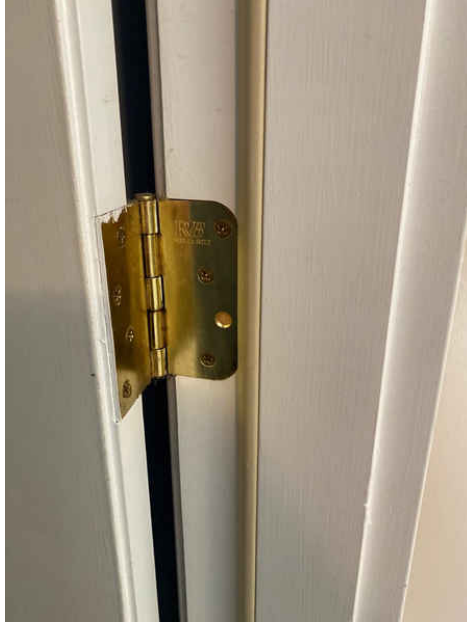
Garage Door Missing Screw

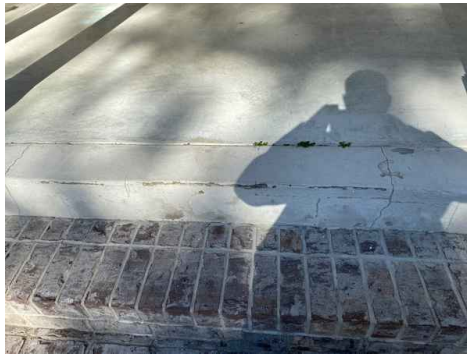
Minor cracking due to settlement

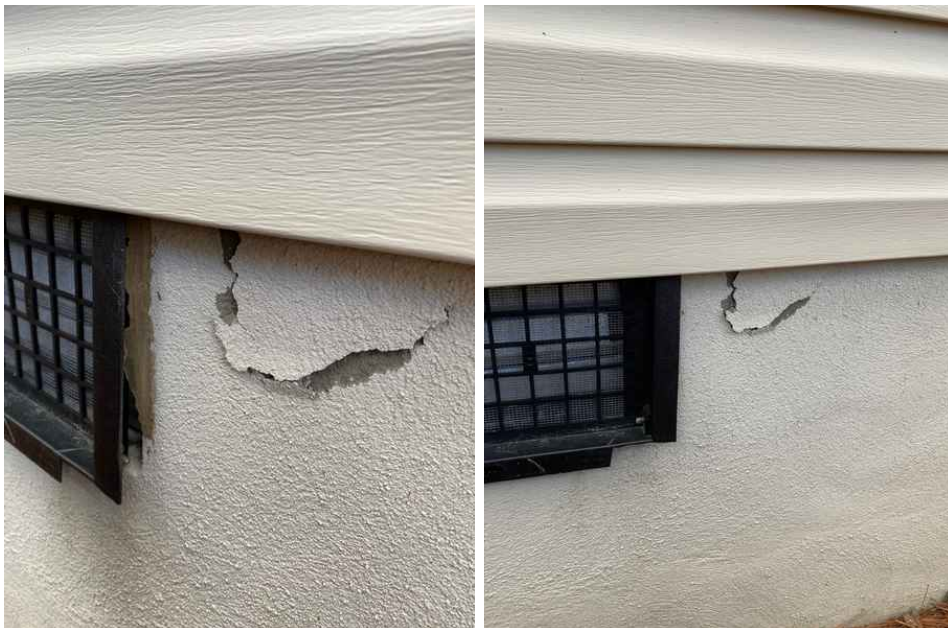
### 2.1.1 Siding, Flashing & Trim

#### **UNKNOWN DAMAGE - MINOR**

Damage to siding in left rear of the home on the stucco. This may have been accidental damage; and could cause further damage. No further damage noted at time of inspection.

Contact a qualified professional.

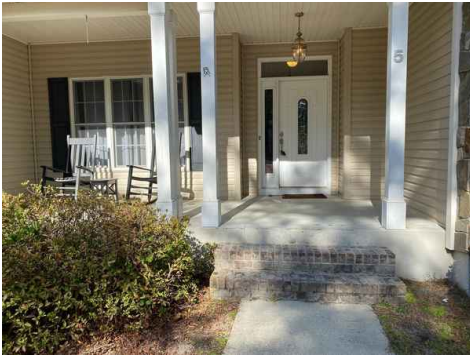
### 2.4.1 Decks, Balconies, Porches & Steps

#### **MISSING RAILING**

Railing was not present at front of home. This is a safety hazard that could result in a trip or fall.

Recommend contacting a professional to install railing.

Contact a qualified professional.

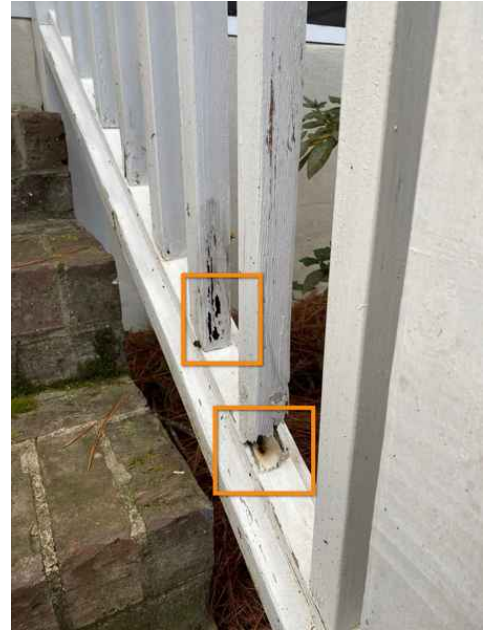
Wood Rot On Spindles

### WOOD ROT

Rotted spindle was noted on the rear entryway to the house. This can result in an opening greater than 4 inches. An opening greater than 4" is a serious safety hazard especially for children as their head or other body part can become trapped.

Contact a qualified professional.

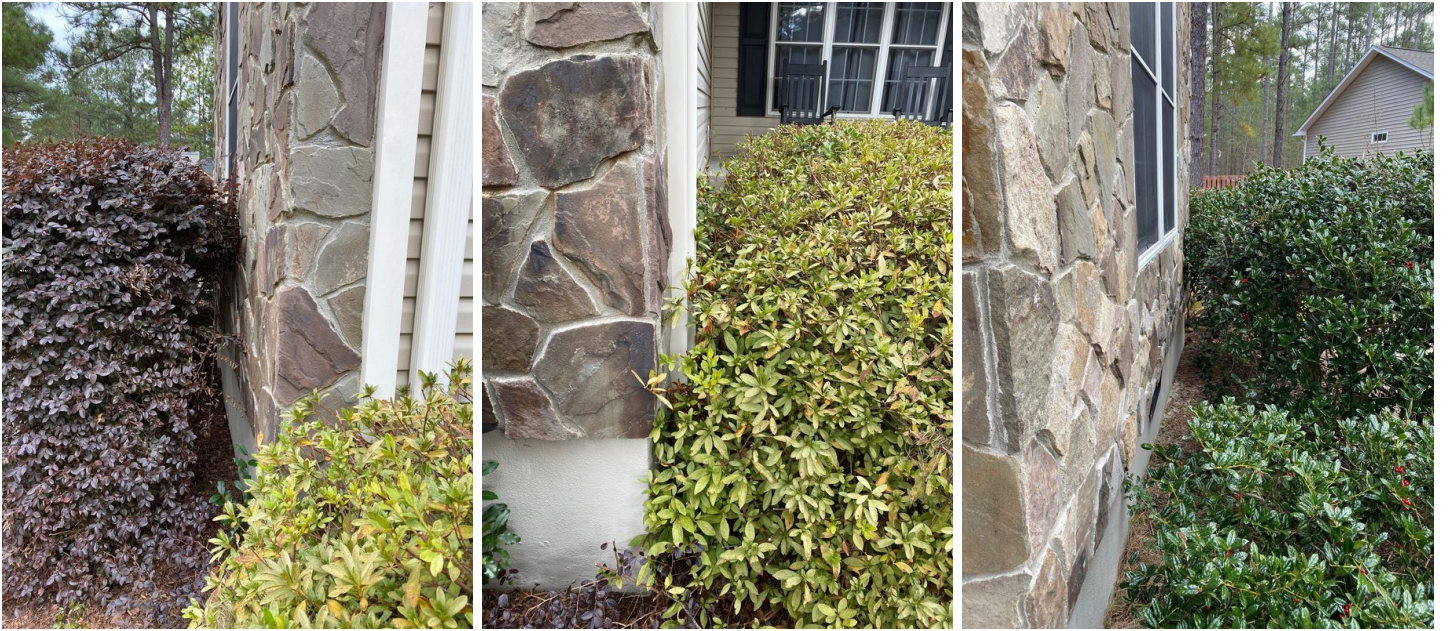
#### 2.6.1 Vegetation, Grading, Drainage & Retaining Walls

### VEGETATION NEEDS TRIMMED

Vegetation touching siding of the house. This could allow water and pest intrusion.

Recommend trimming vegetation back at least one foot from house.

Recommended DIY Project

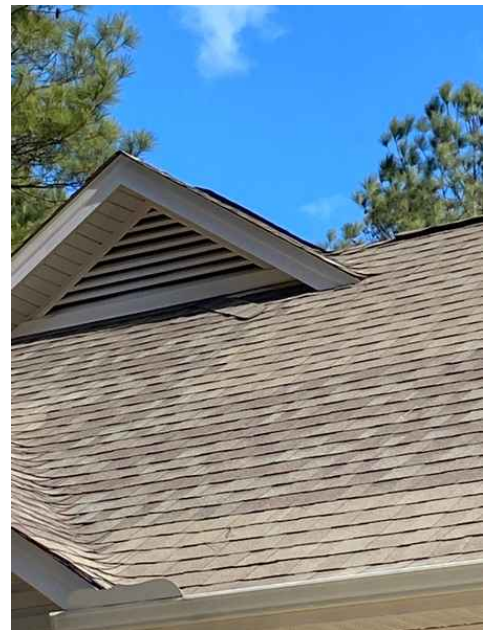
Gable Above Garage

### DAMAGED (GENERAL)

Roof coverings showed minor damage. Shingles not attached below Gable Vent. This could allow for water intrusion. Recommend a qualified roofing professional evaluate and repair.

Contact a qualified handyman.

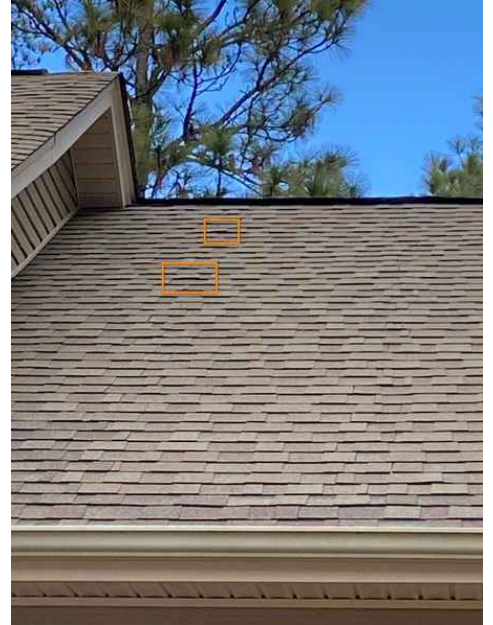
## 3.1.2 Coverings

Lower Priority**UNDER-DRIVEN NAILS**

Observed one or more under-driven nails/fasteners. Recommend a qualified roofing contractor evaluate and repair.

Contact a handyman or DIY project

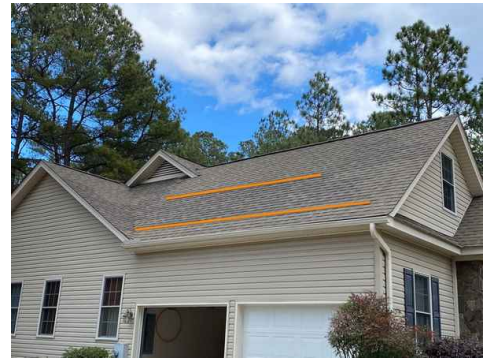
## 3.1.3 Coverings

Monitor**DISCOLORED SHINGLES**

Shingles over garage are two different shades. No current signs of leaking from the area. Recommend verifying with current owner to see if there was previous damage.

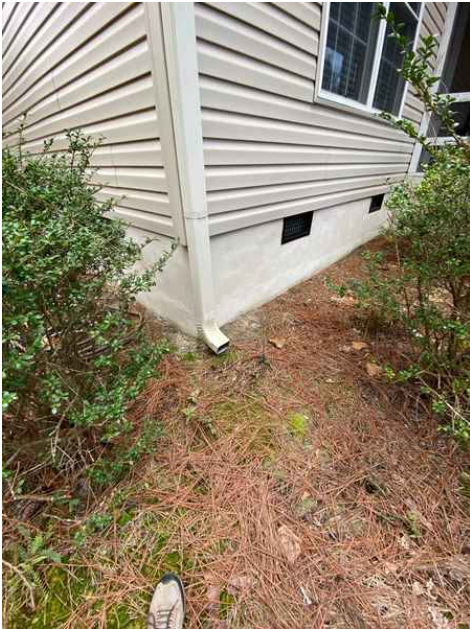
Right Rear

Lower Priority**DOWNSPOUTS DRAIN NEAR HOUSE**

One or more downspouts drain too close to the home's foundation. This can result in excessive moisture in the soil at the foundation, which can lead to foundation/structural movement. Recommend a qualified contractor adjust downspout extensions to drain at least 6 feet from the foundation.

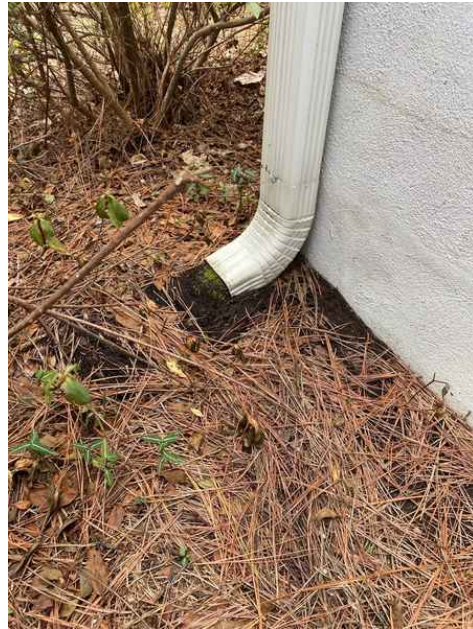
Rear, clogged with debris.

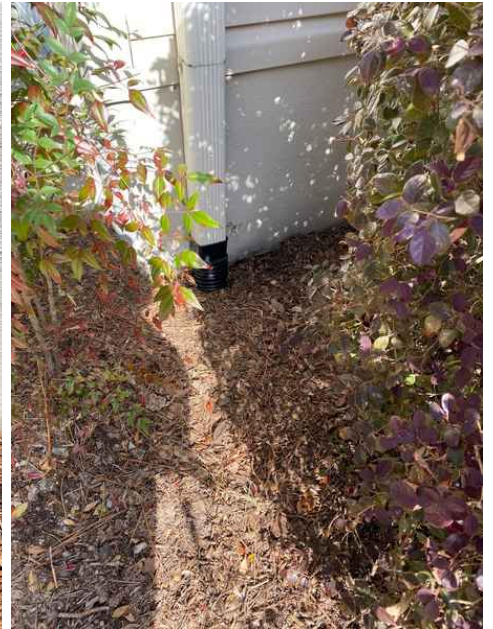
Left front. Was not able to determine end of downspout

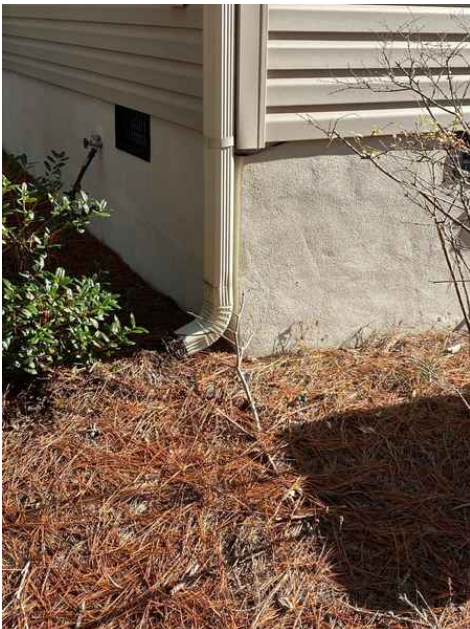
Left Rear downspout clogged with debris.

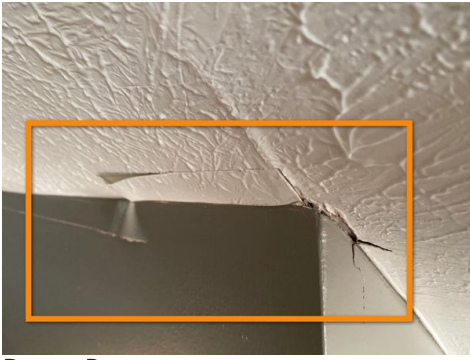
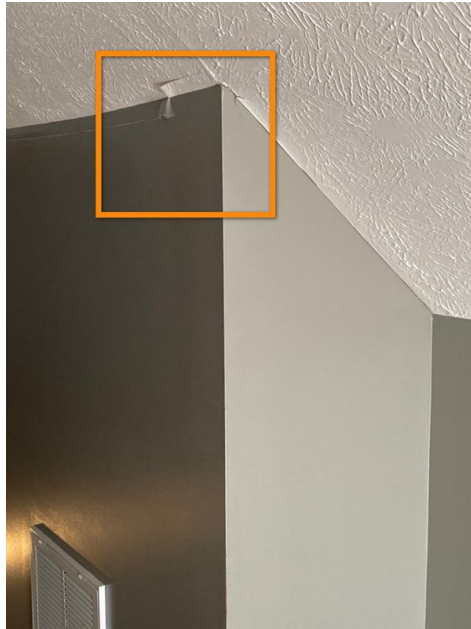
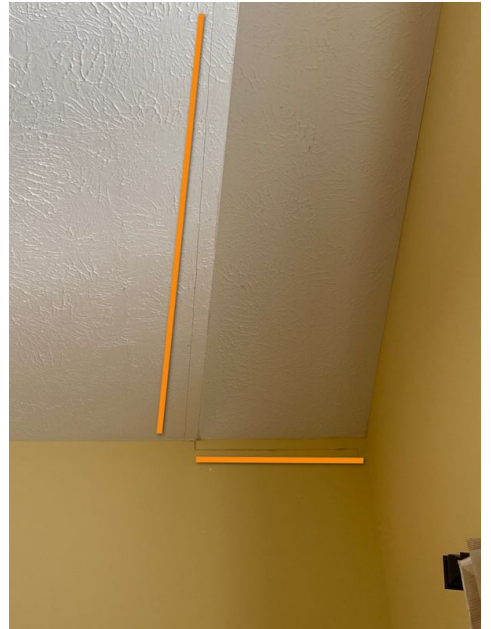
### 4.4.1 Walls

#### **POOR PATCHING**

Sub-standard drywall patching observed at time of inspection. Recommend re-patching.

Contact a qualified drywall contractor.

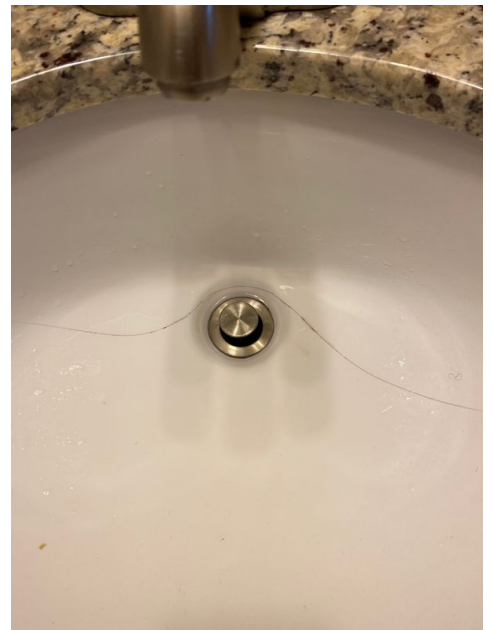
BATHROOM 1

### **CRACKED SINK**

Cracked sink in Bathroom 1. Evidence of water seepage was noted under sink. This could worsen over time. Recommend qualified handyman or professional to replace.

Contact a handyman or DIY project

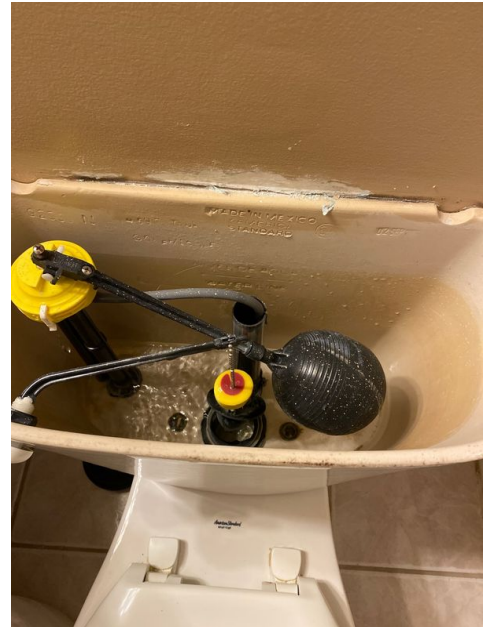
## 7.3.2 Water Supply, Distribution Systems &amp; Fixtures

Lower Priority**TOILET RUNNING**

Toilet in bathroom 1 continues run after flushed. This could be due to improper installment or defective parts within the tank. Recommend qualified handyman or professional to evaluate and fix.

Contact a handyman or DIY project

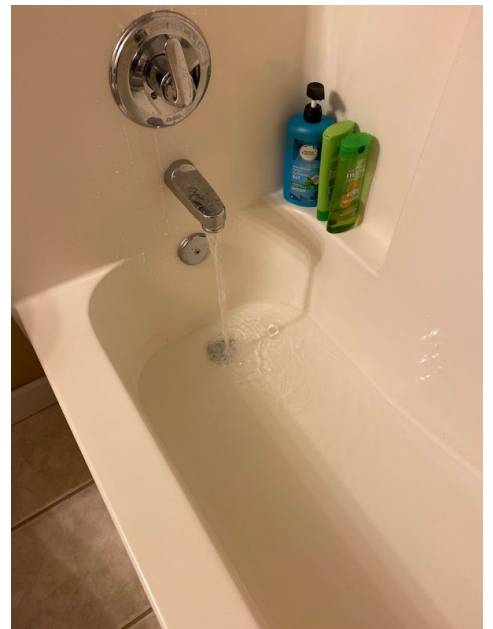
## 7.3.3 Water Supply, Distribution Systems &amp; Fixtures

Lower Priority**SLOW DRAINING TUB**

Bath Tub in bathroom 1 drains slower than it should. This could be due to a partial clog. Recommend qualified handyman or professional to evaluate and clear drain.

Contact a handyman or DIY project

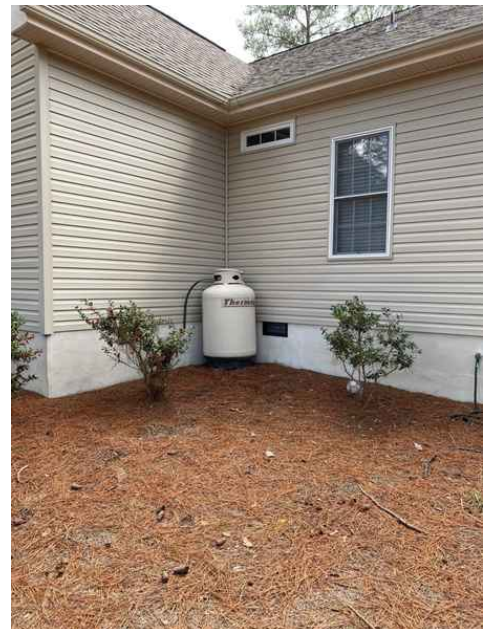
Too Close to House

#### **PROPANE TANK TOO CLOSE TO HOUSE**

Propane Tank was too close to the house. For safety reasons, propane tank should be minimum 10 feet away from house and no closer than 5 feet from a window.

Recommend evaluation from Propane Supplier.

Contact a qualified professional.

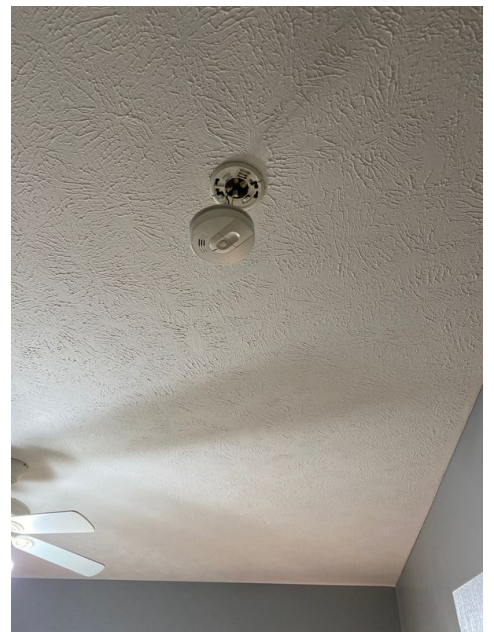
BEDROOM 1

Hanging smoke detector in bedroom 1. This could cause the detector to not function properly. Recommend remounting the detector.

Recommended DIY Project

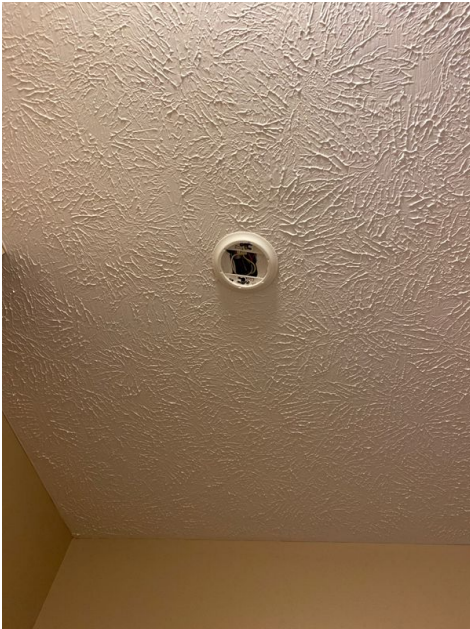
### 8.6.2 Smoke Detectors

#### **MISSING SMOKE DETECTOR**

Smoke detector was missing from left side hallway. However, smoke detectors have been installed in bedrooms. Recommend inquiring with current homeowner.

Contact the seller for more info

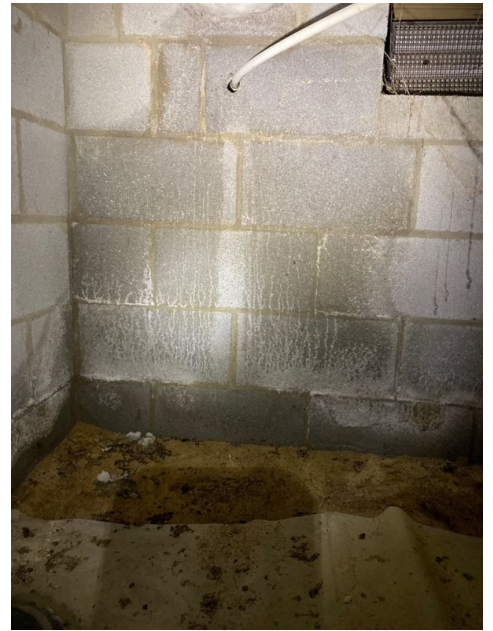
#### **HIGH MOISTURE LEVELS**

High levels of moisture were noted in areas of the crawl space. Recommend monitoring and finding source of moisture intrusion to prevent damage to structure.
